# MORRIS COUNTY HISTORIC SITES SURVEY

New Jersey Historic Sites Inventory  
MORRIS COUNTY CULTURAL RESOURCES SURVEY

It is this cooperative effort that made possible this Historical/Architectural Survey of the Borough of Chester, Morris County, New Jersey.

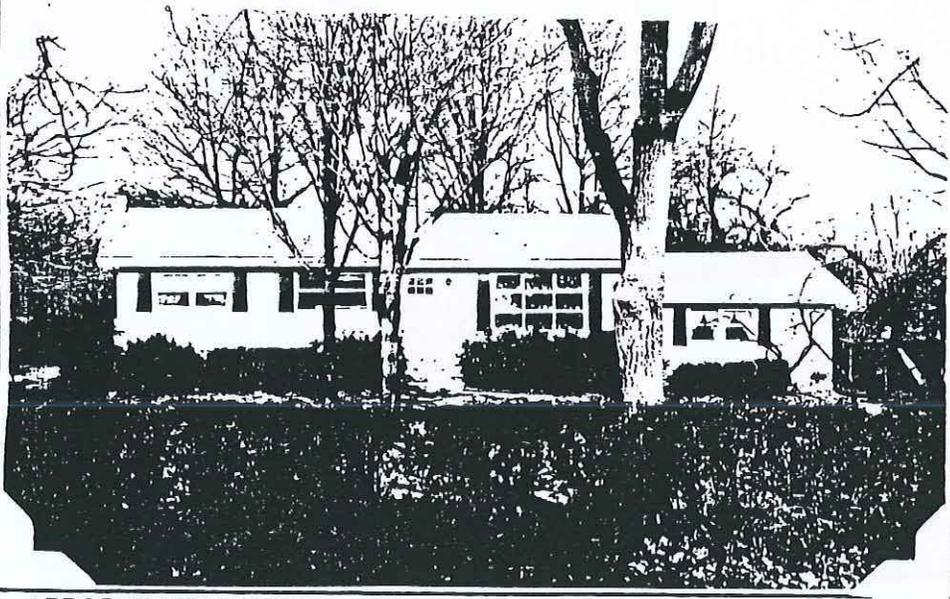
ADDRESS/DESCRIPTION: 43 North Road

CONDITION: Good

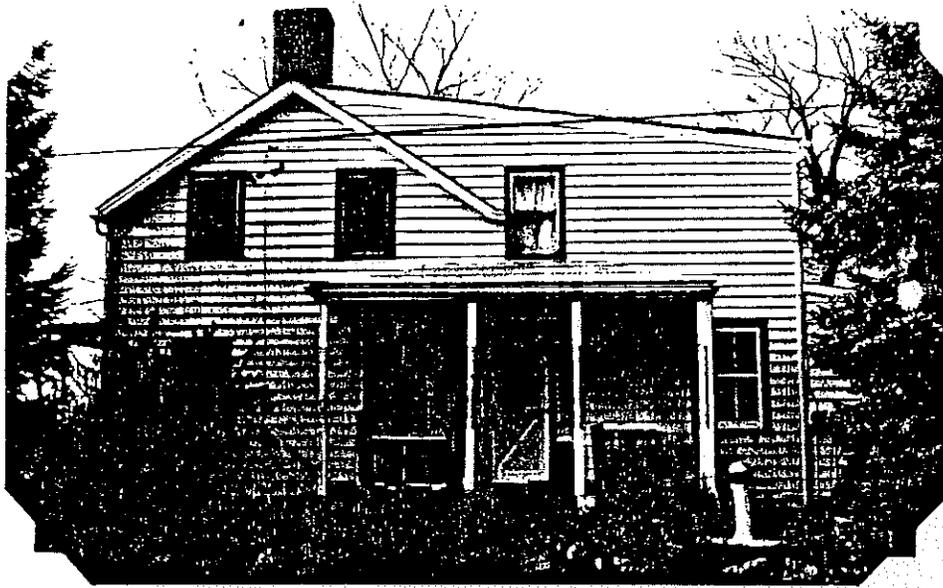
ADDRESS/DESCRIPTION: 7 Williamson Lane

Age uncertain

CONDITION: Fair

This house may possibly be the property of "N. A. Cooper" as noted on the 1853 map. Its south-facing situation could support a relatively early construction date, but only an interior examination coupled with documentary research could reveal more about it.

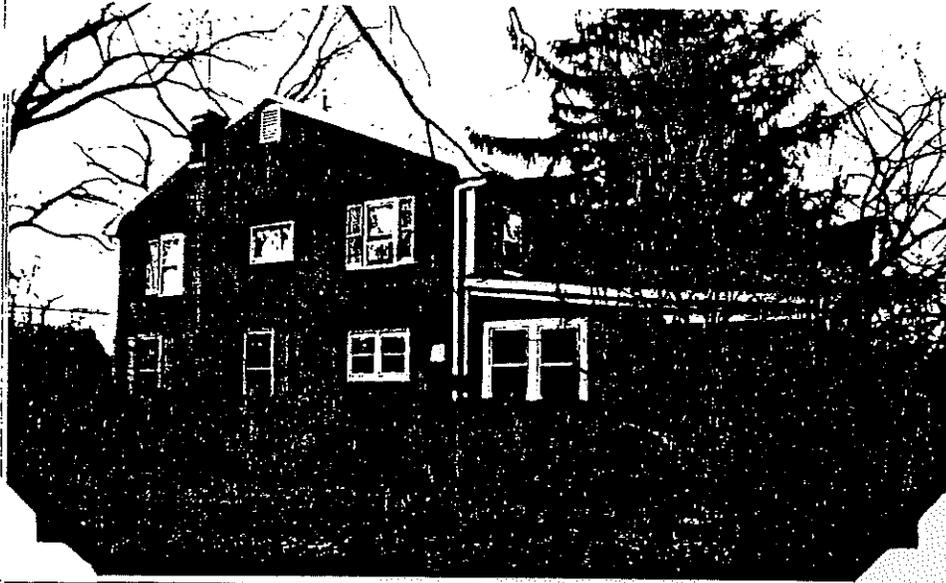
ADDRESS/DESCRIPTION: 31 North Road at Williamson Lane c. 1850 or earlier

2-story shingled house with broad gable ends and 2-bay facade without entrance. Entire house is so altered and modernized that age and style are impossible to determine.

CONDITION: Good INTEGRITY: Poor USE: Residential

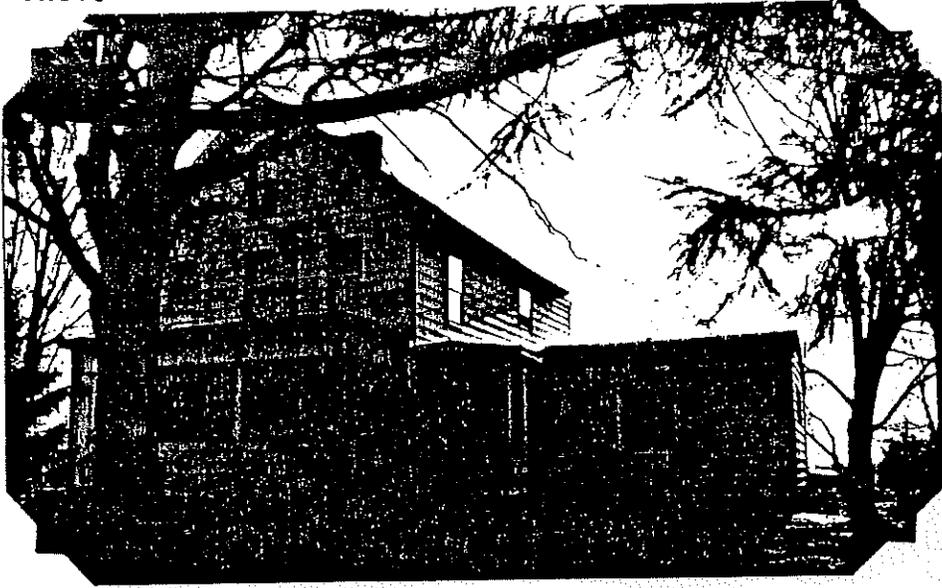
ADDRESS/DESCRIPTION: 42 (38) North Road

2 1/2-story, 3-bay planbook farmhouse with gable-end to road. Appearance totally denatured with enclosed porch and aluminum siding.

CONDITION: Good

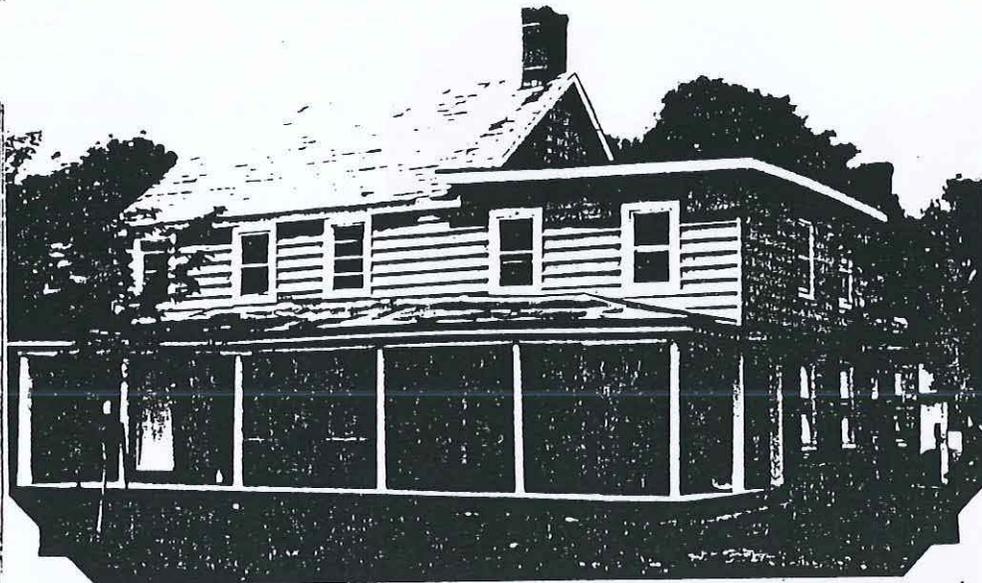
ADDRESS/DESCRIPTION: 9-15 North Road

c. 1850

CONDITION: Poor

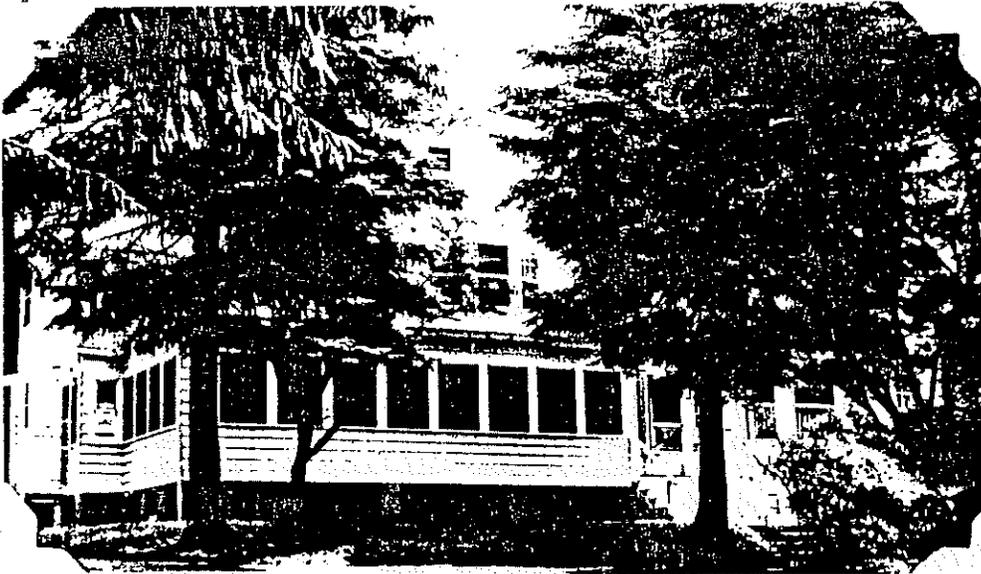
ADDRESS/DESCRIPTION: Grace Bible Church, 100 Oakdale Road

The oldest buildings on the property are a frame house (c. 1910) with gable roof, 6/1 sash, enclosed porch and no architectural integrity, and a dairy farm dating from the first third of the 20th century. It has cement walls and an asphalted gambrel roof, new windows and doors, and is being renovated for classroom use. It occupies a slight elevation in a field, behind a drywall retaining wall of oversized boulders. Between house and church stands a c. 1970 concrete and brick veneer church with prefab steeple on a gable roof. Attached is an 8-bay Sunday School wing. A gravel parking lot is the front yard of the church. Various small outbuildings lie between church and house. A winding drive, lined with pine trees, gives access from Oakdale Road.

CONDITION: Good

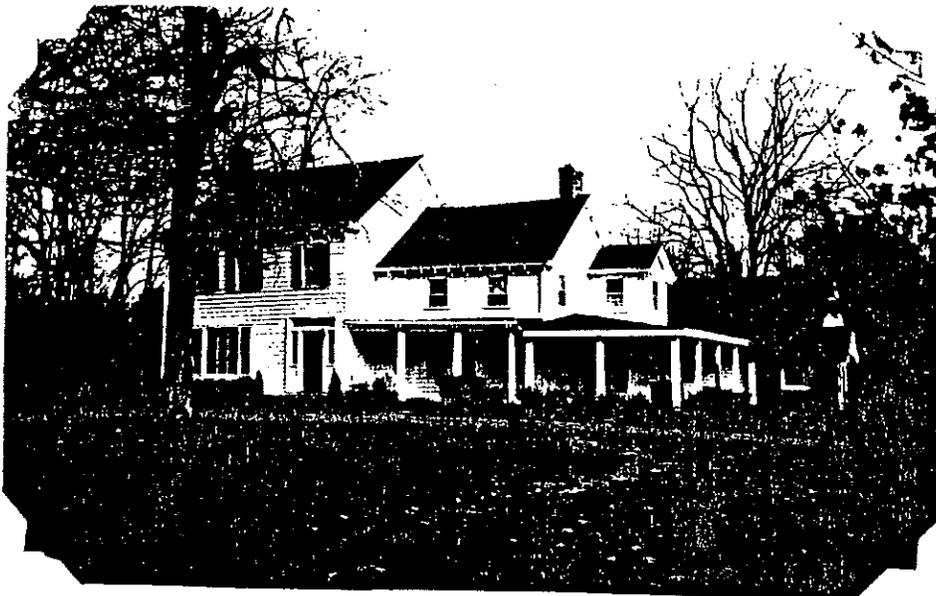
PHOTO Negative File No. 28-4

Fenestration: 9/6 on main block, ground-floor facade windows replaced with "picture" window.

Roof/Chimneys: interior end brick chimneys (1 replaced)

Additional Architectural Description: 3-bay side-hall wing has door with transom and sliding sash sidelights. Door itself is multi-light replacement. Smaller wing is 2-over-3 bays. Its centered door has flanking windows butted directly against it. Both wings have bracketed cornices. A flat-roofed porch to the south and east connects the house to a new vertical-board garage, sensitively detailed in the manner of a gabled outbuilding.

SITING, BOUNDARY DESCRIPTION, AND RELATED STRUCTURES: The house is set back from the road on an open grassy lot with trees at front and back. On the front lawn, a few yards from the house, is a blocky fieldstone building about 5' square with wooden gable ends, projecting eaves and 3 fixed windows. The door is batten and the floor has a trapdoor.

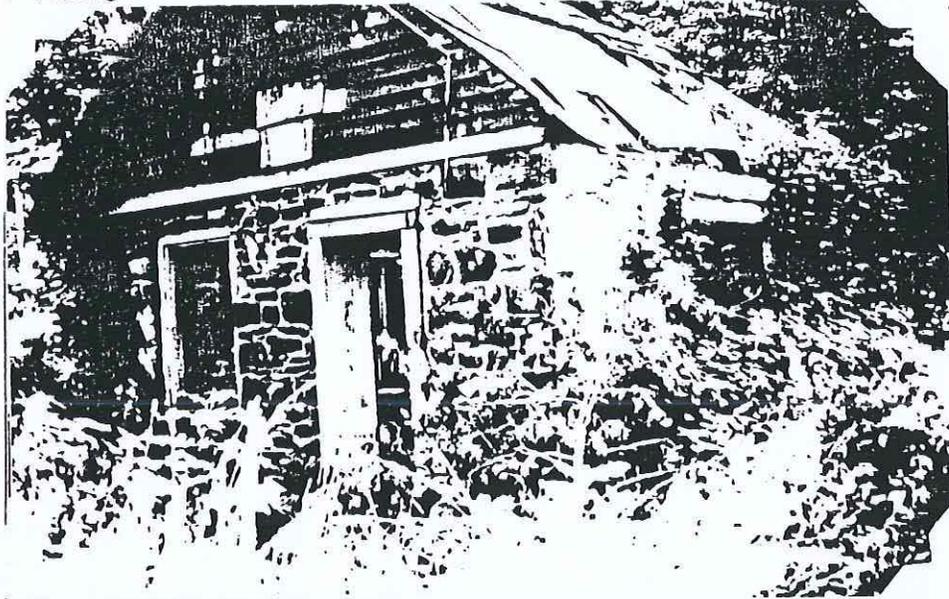
ADDRESS/DESCRIPTION:

Early 20th Century

CONDITION: Ruinous

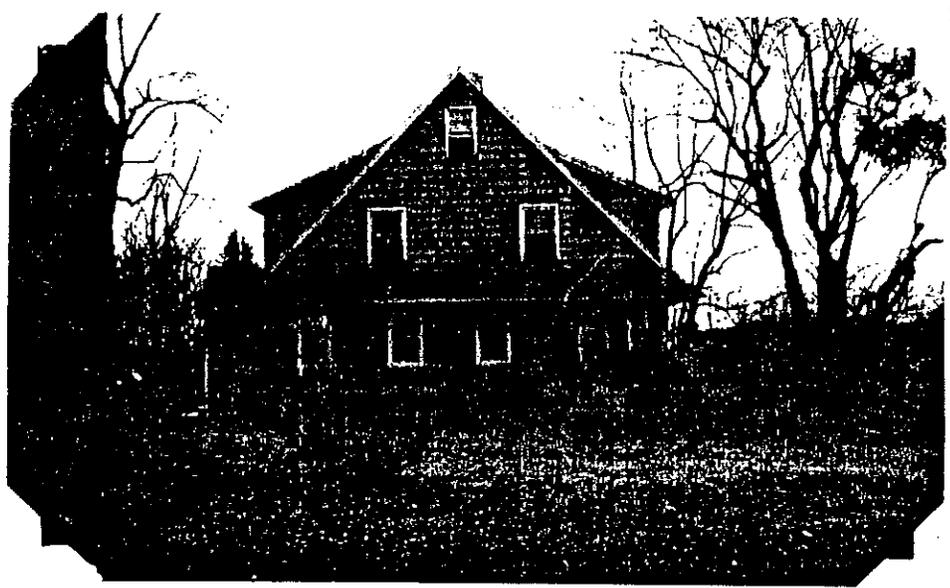
PHOTO Negative File No. 29-?A

Construction Date: c. 1890-1900  
Architect:  
Style: Bungalow/cottage, shingle style influence  
Number of Stories: 2 1/2  
Foundation: rubblestone  
Exterior Wall Fabric: Wood shingles  
Fenestration: 8/1 sash  
Roof/Chimneys: Steep gable with shed dormers north and south; interior brick chimneys  
Additional Architectural Description: Entry facade faces north, away from road. Integral front porch supported on grouped Doric columns. Compare house #97.

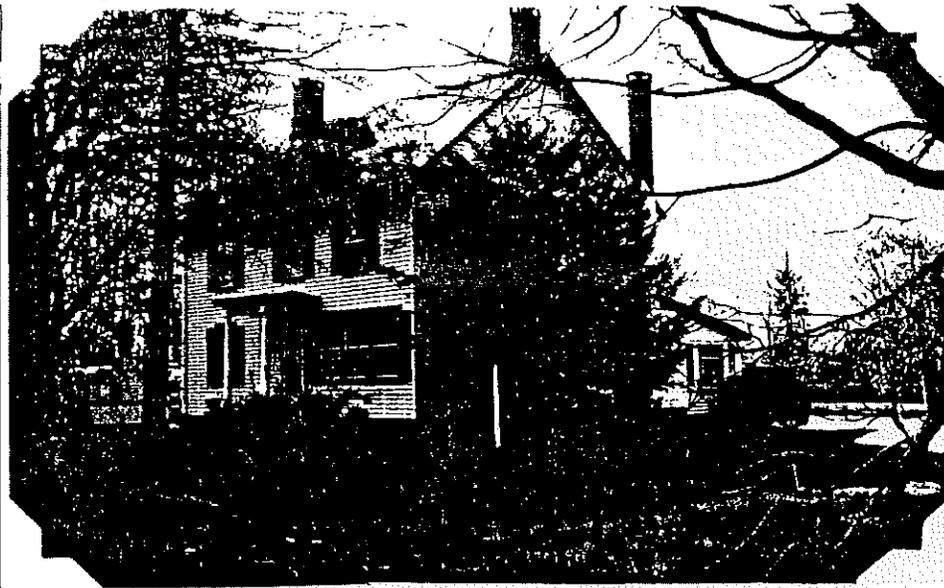
INVENTORY # 1406-060

2 1/2-story clapboard farmhouse; 3-bay center-hall with gable roof and 2 end chimneys, rubblestone foundation; some 2/2 sash with new batten shutters; tripled front window. Flat-roofed entry portico on Doric columns.

CONDITION: Good

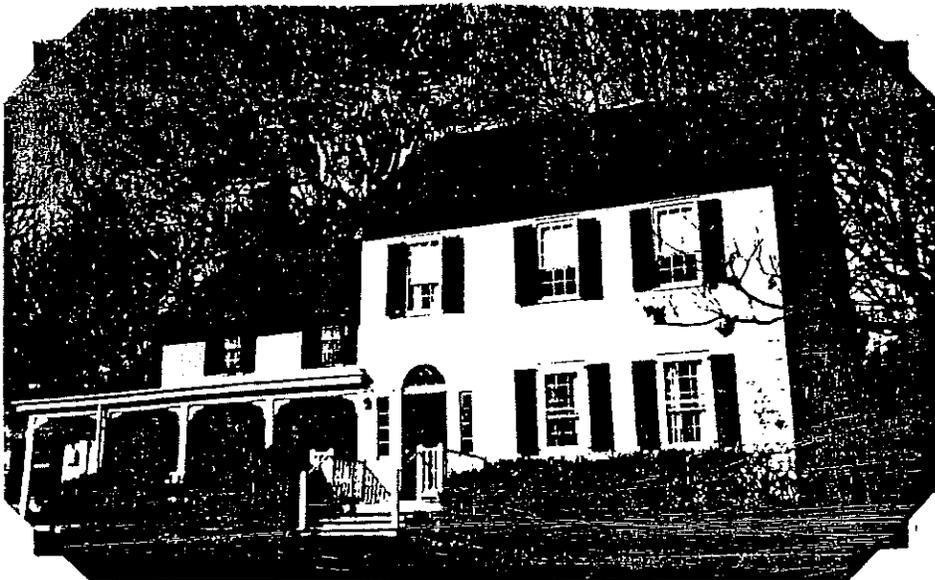
SITING, BOUNDARY DESCRIPTION, AND RELATED STRUCTURES: The house faces south, looking down into the village. Behind it stand 2 19th/20th century clapboard barns in deteriorating condition.

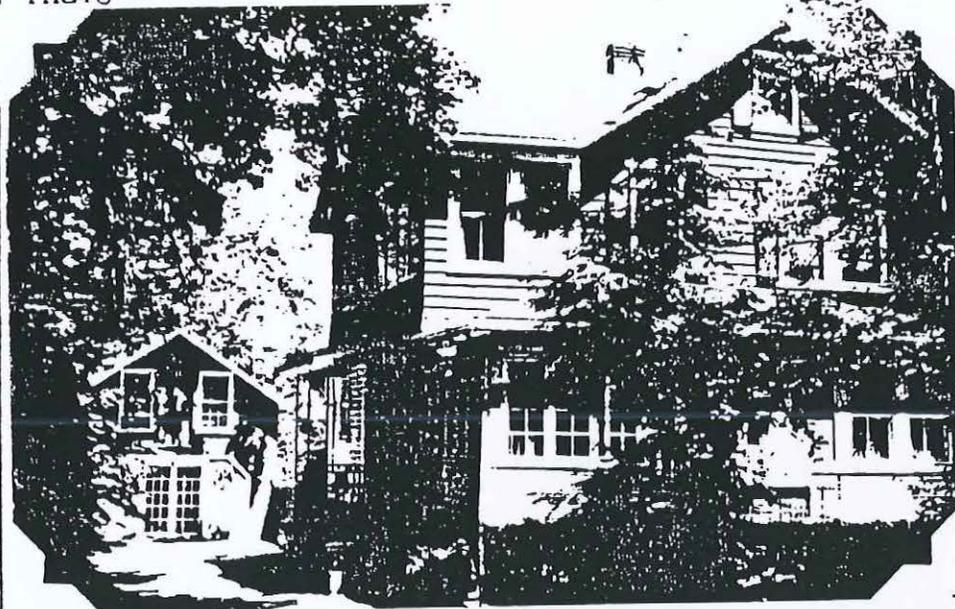
ADDRESS/DESCRIPTION: 285 Main Street

2 1/2-story much-altered vernacular house with asphalt shingled gable, wood shingled walls and 2/2 sash. Originally an L-plan, it is now filled-in to form a 3-bay house with side gables. An enclosed porch covers the entire ground-floor facade.

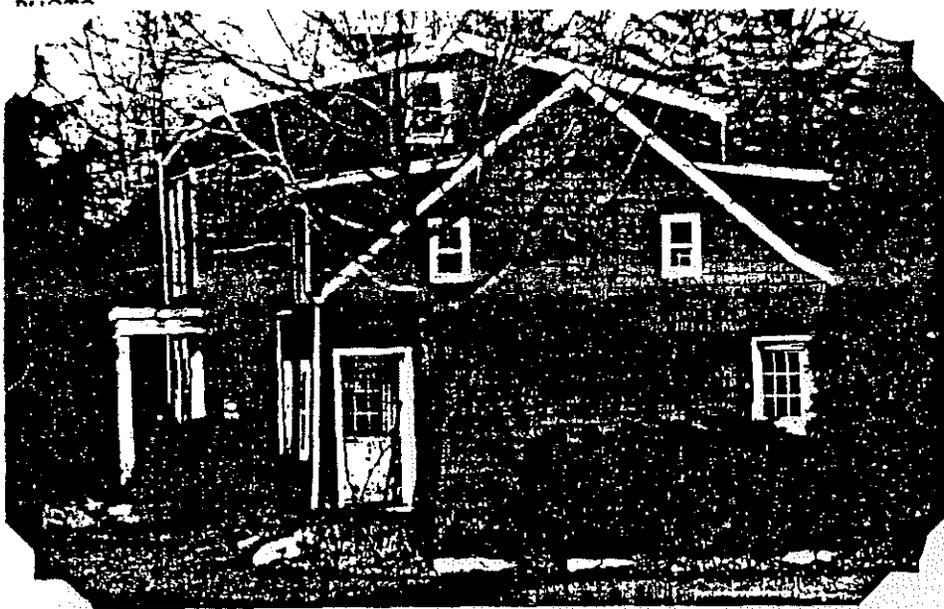
ADDRESS/DESCRIPTION: 333 Main Street

2-story block-and-wing house with gabled roofs and modern shingle siding probably obscuring some original detailing. Large section has a 3-bay side-hall facade with transom-and-sidelight entry and flat-roofed portico on piers. The small wing is 2 bays. Both sections have 6/6 sash. A frame outbuilding at the rear and a garage/store to the east are of no architectural significance.

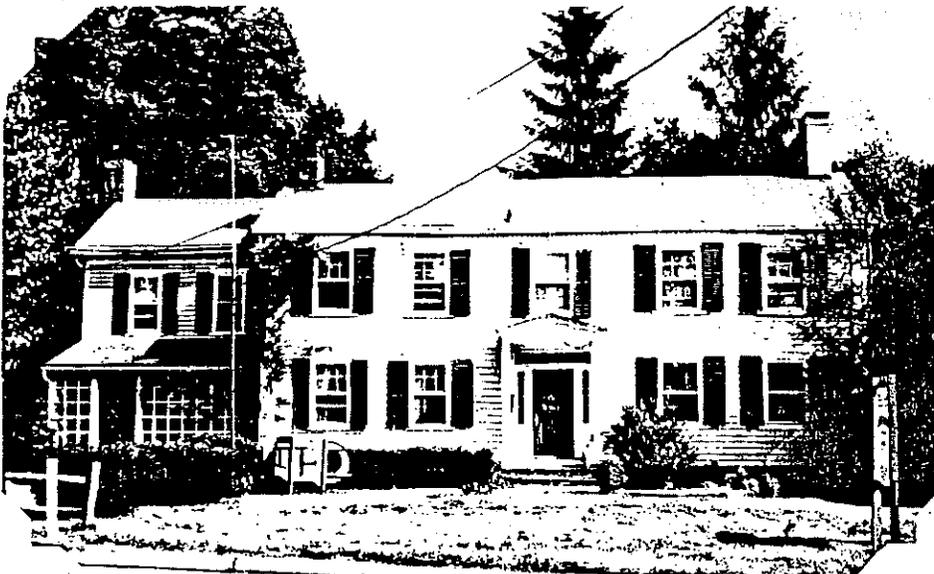
PHOTO Negative File No. 2-13

Moderate setback with appropriate but overgrown landscaping. Gravel parking lot to the east includes 2 small shed-like buildings of no architectural significance, used as antiques shops.

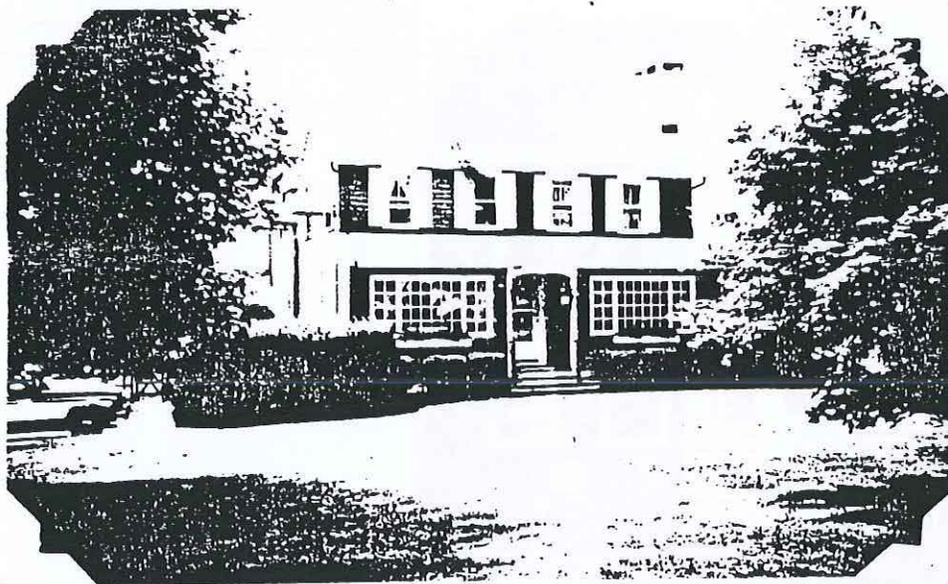
ADDRESS/DESCRIPTION: 41 Fairmount Avenue mid-19th century

Vernacular house, much modified. Probably it originated as a single pile farmhouse, large rear additions have deepened the structure, facade porch is enclosed and treated as an extension of the structure.

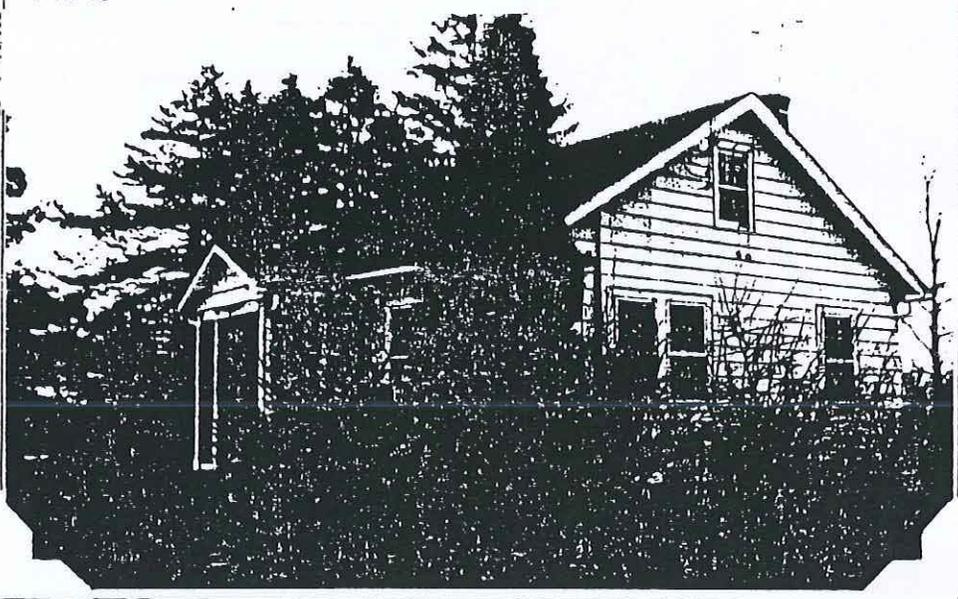
ADDRESS/DESCRIPTION: 460 Main Street c. 1910-1930

This 1-story gabled and clapboarded cottage is 3-bays with an enclosed projecting portico. Windows are 6/6 sash, single and paired. It stands within about 6 feet of the road on an overgrown lot. Immediately to its west stands an abandoned shedlike fruit stand constructed largely of assorted salvaged windows.

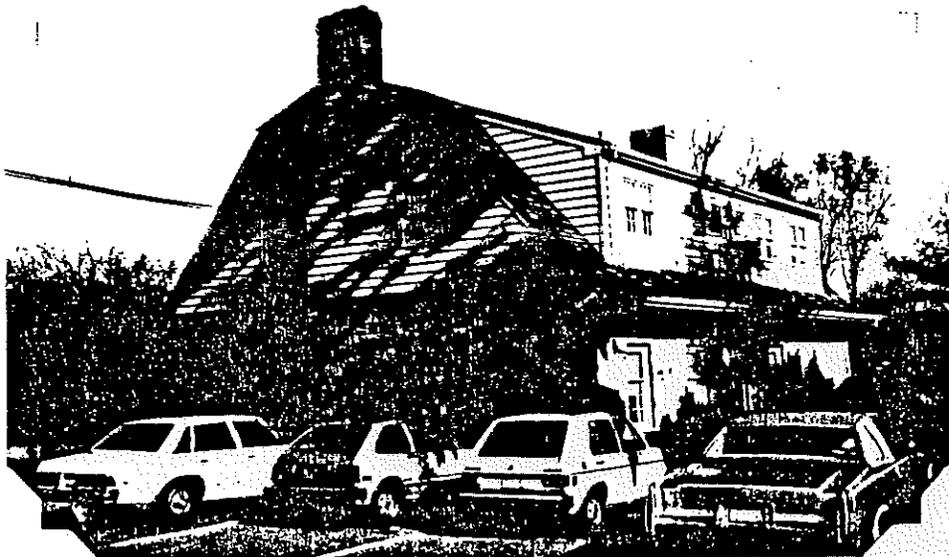
ADDRESS/DESCRIPTION: 444 Main Street at Sentry Lane

The Carteret Savings building is a 1 1/2-story Dutch Colonial Revival structure with sandstone walk, kicked gambrel roof and 5-bay facade.

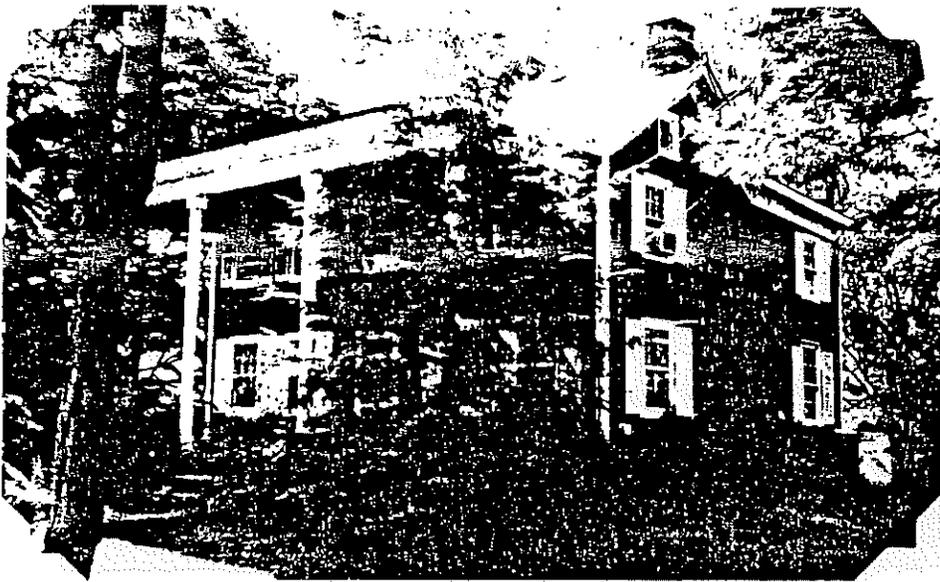
248 Main Street

5-bay center-hall plan, 6/6 sash windows. "Rustick" shingle siding. Facade porch added early 1960's.

CONDITION: Good

This kind of single pile-house, also found at #47, 41, 50 and 44 Main Street, appears to be a transitional 18th-19th-century type locally. This particular house appears on the 1868 and 1887 Maps of Chester as the residence of E. Pitney.

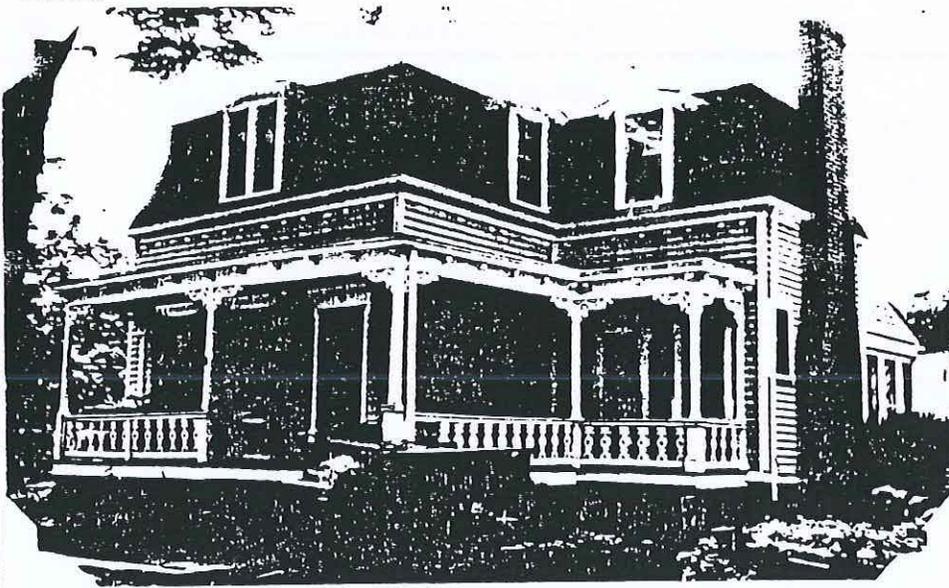
266 Main Street

1 1/2-story frame T-plan mansard cottage with 2/2 dormers and full-length ground floor windows. Porch brackets, balustrade and window heads are cut in fanciful jigsaw patterns. Stone foundation, heavily molded roof curbing and cornice. Adjacent is a 1-story vertical-sided mock-mansard building, c. 1960-1970. At rear of the lot is a mid-19th-century vertical sided barn. The front yard is a gravel parking lot.

CONDITION: Good

Mansard cottages are found in a number of architectural pattern books, but are rare in Morris County. This well-preserved example adds variety to Main Street.

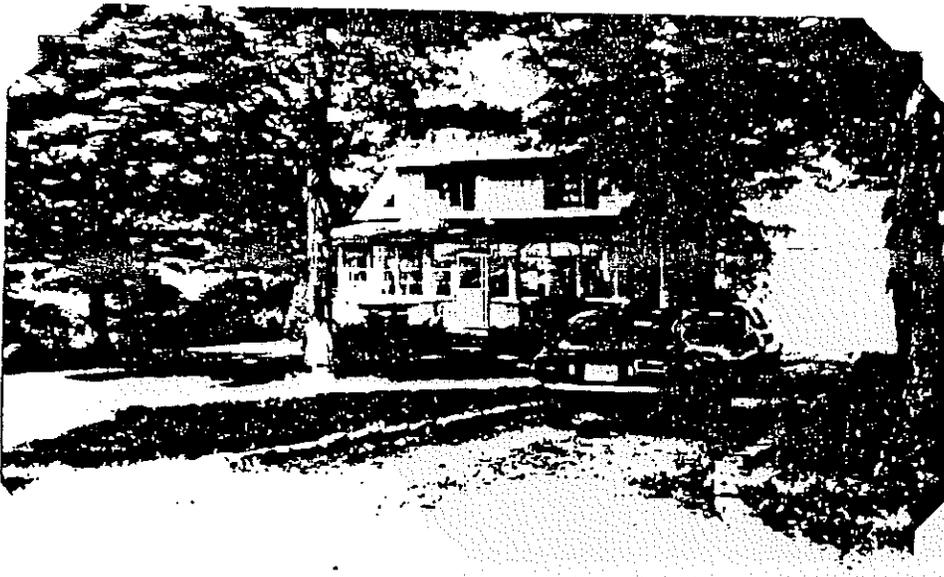
106 Fairmount Avenue (corner Grove Street)

Shed roof facade porch with replacement supports on stone piers, wooden railing.

1/1 sash windows. Center front door = replacement.

CONDITION: Fair/Good

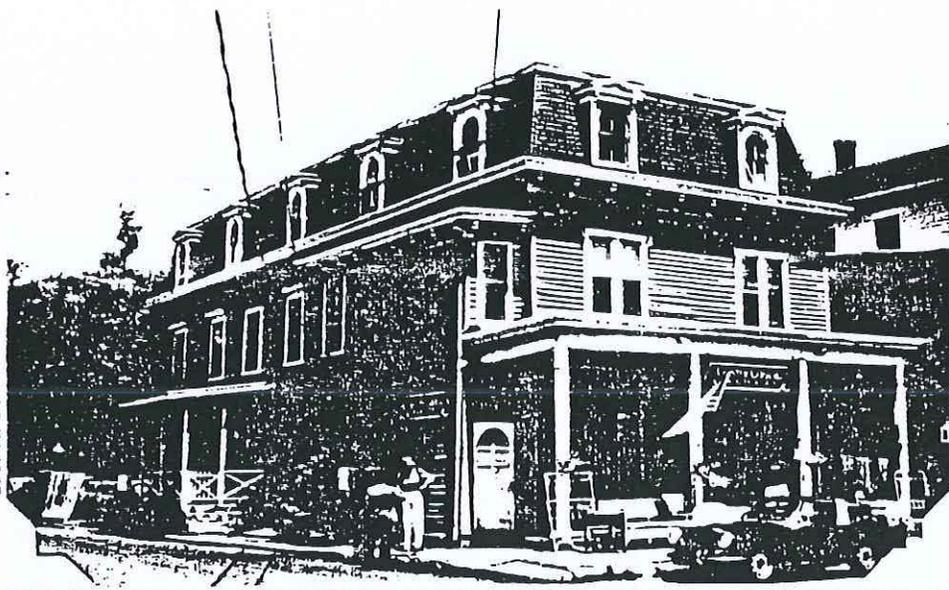
123-125 (125) Main Street

Vernacular Second Empire commercial building. 3 story, straight-sided mansard roof, asphalt shingles. Dormers with pediments supported on brackets, round-arched window heads. Heavy bracketed and paneled frieze supporting moulded cornice (continues all around building). Clapboard siding. 2-bay facade. Paired narrow 1/1 windows under eared moulding. Store front under tall flat-roof porch, pier supports. Extra-large plate glass display windows now divided by muntins. Center double doors replaced with aluminum doors.

CONDITION: Good

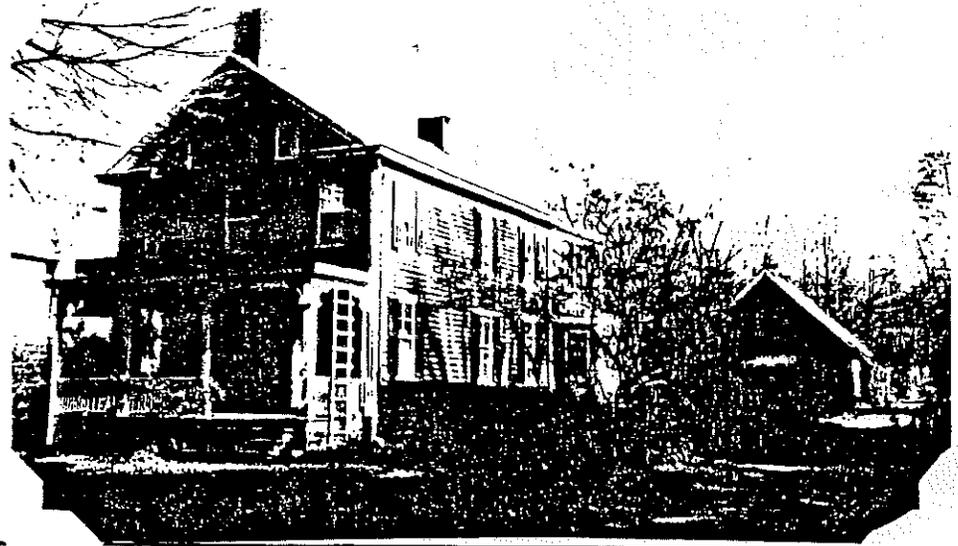
ADDRESS/DESCRIPTION: 15 Church Street

Built between 1868 and 1887

Planbook style house. 2 1/2 story.  
 3-bay gable-end facade, side-hall plan.  
 Gable roof, gable end returns, 2 interior end chimneys.  
 Stone foundation, clapboard siding.  
 4/4 sash windows, original blinds at windows, 2-bay attic windows. Bay windows on each side of house.  
 Wide frieze below eaves reflects lingering Greek Revival influence.  
 Facade porch with chamfered posts, caps, and jigsaw spandrels.  
 Front door surrounded with transom and sidelights.  
 1-bay rear wing, 1 1/2-story frame garage at rear of property.

CONDITION: Excellent

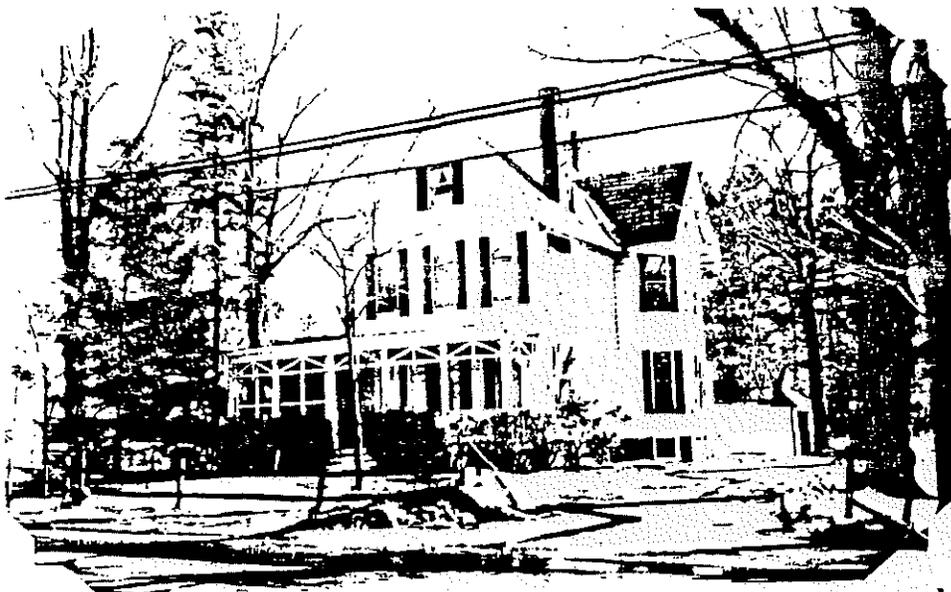
ADDRESS/DESCRIPTION: 170 (184) Main Street

Built 1882-3

Steep gable roof, slate shingles, end chimney. Brick foundation, aluminum siding. 2 1/2-story, 3-bay gable-end facade, side-hall plan house with 2-story wing to east side. Replacement windows, fake blinds; bay window on side of house. Facade porch with stickwork frieze in kingpost motif; carved drop pendant. East end of porch now screened in. 2-story garage/apartment in rear - 19th century frame outbuilding with simple stickwork at eaves.

CONDITION: Good

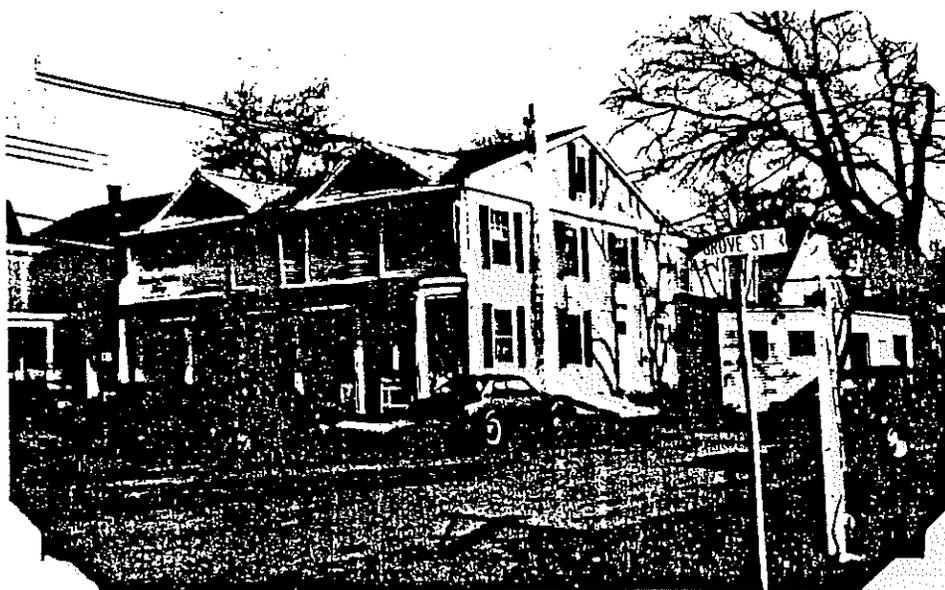
110 (128) Main Street

CONDITION: Fair

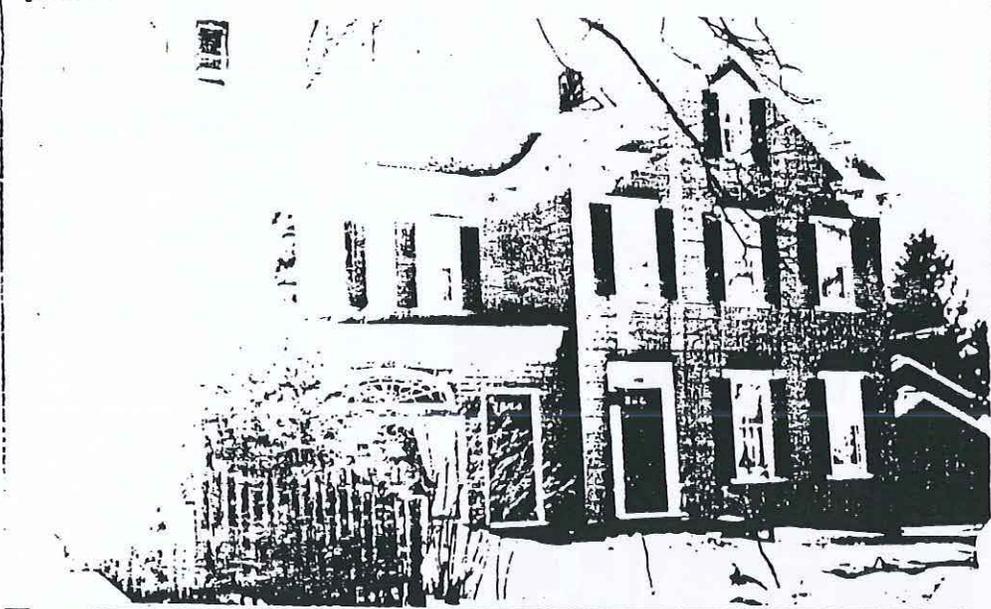
ADDRESS/DESCRIPTION: 24 Budd Avenue Built between 1868 and 1887

Italianate vernacular house. "L" plan. 2 1/2 stories. Gable roof, wide bracketed eaves, gable-end-returns, end chimney.

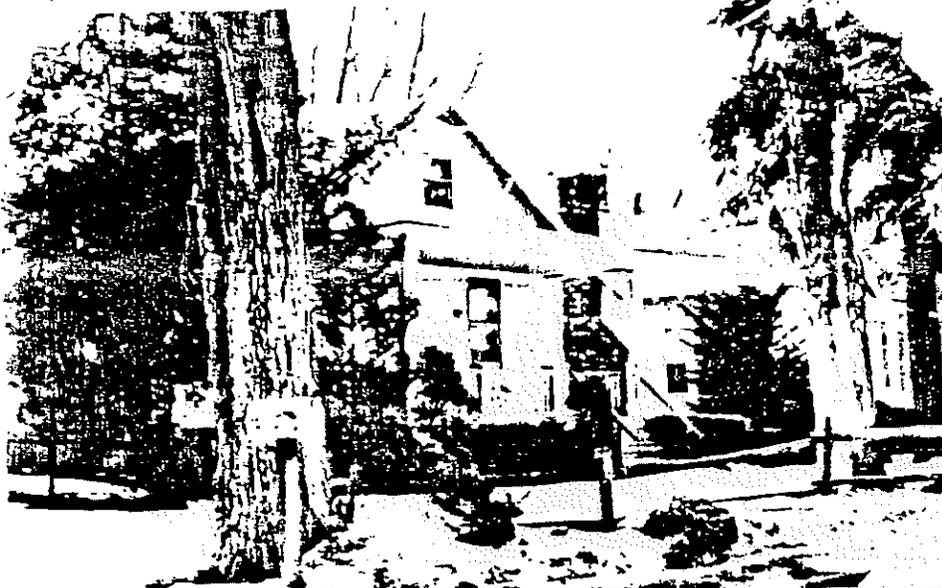
A DESCRIPTION: 42 (38) Budd Avenue ca. 1920

Bungalow. Gable-end facade.

Concrete foundation.

CONDITION: Good

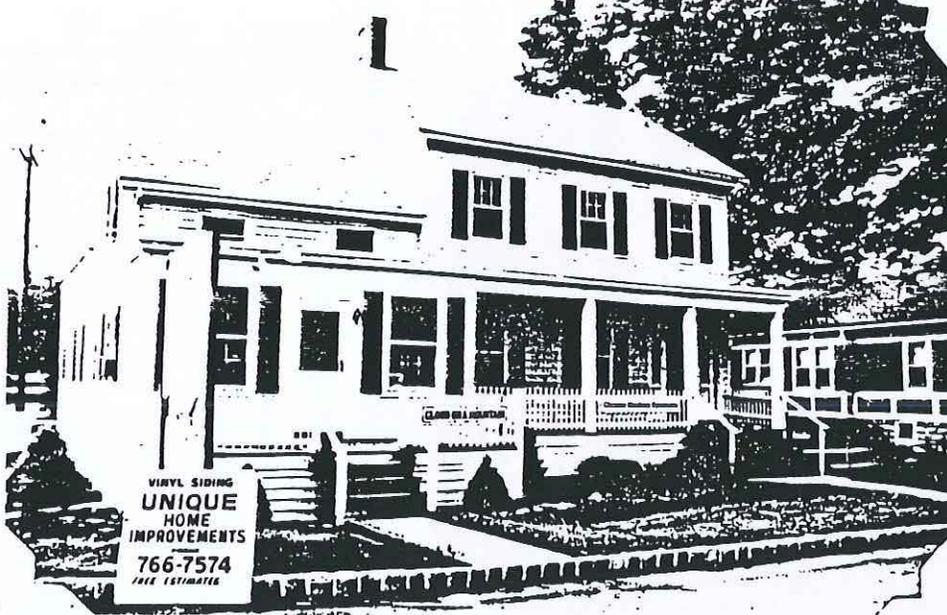
ADDRESS/DESCRIPTION: 98 Main Street

Vernacular Federal Style "Block-and-Wing" house. 2 1/2 story block, 3-bay side hall plan. Original 6/6 sash windows, fake blinds. Multi-light transom and side lights. Shed-roof porch with new pillars and balustrade. 2-story "wing" to east side with 2-bay second floor, 3-bay first floor with center door. Projecting flat-roofed storefront recently enclosed on facade, inappropriate raised "deck" in front. Both portions of house have rubble stone foundation, vinyl siding; wooden brackets and other ornament stripped from house when siding applied.

CONDITION: Good

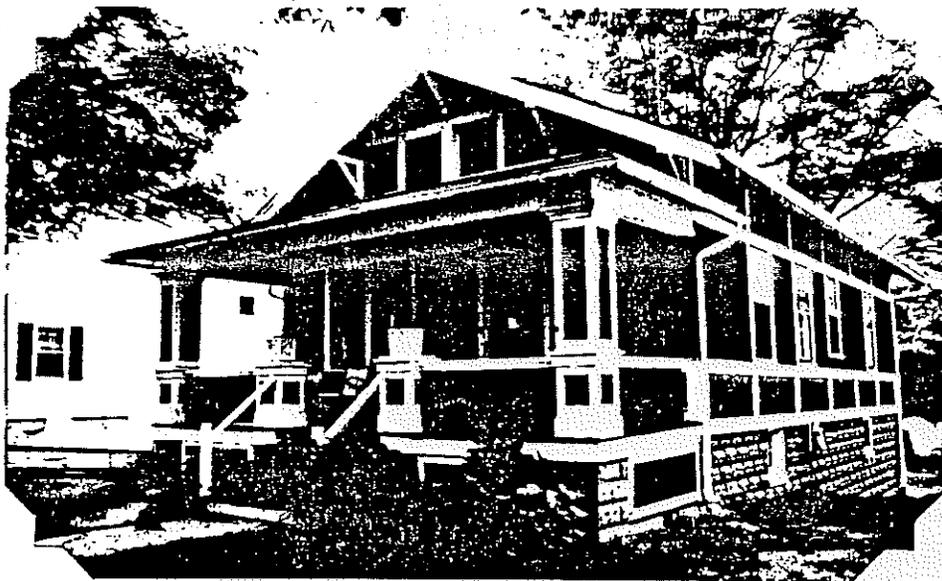
92 Main Street - Conover Cottage

Well preserved Bungalow style house, typical in many details. Rusticated concrete block foundation, shingle siding, facade porch on paneled piers, low gable roof with wide eaves, knee braces beneath.

CONDITION: Excellent

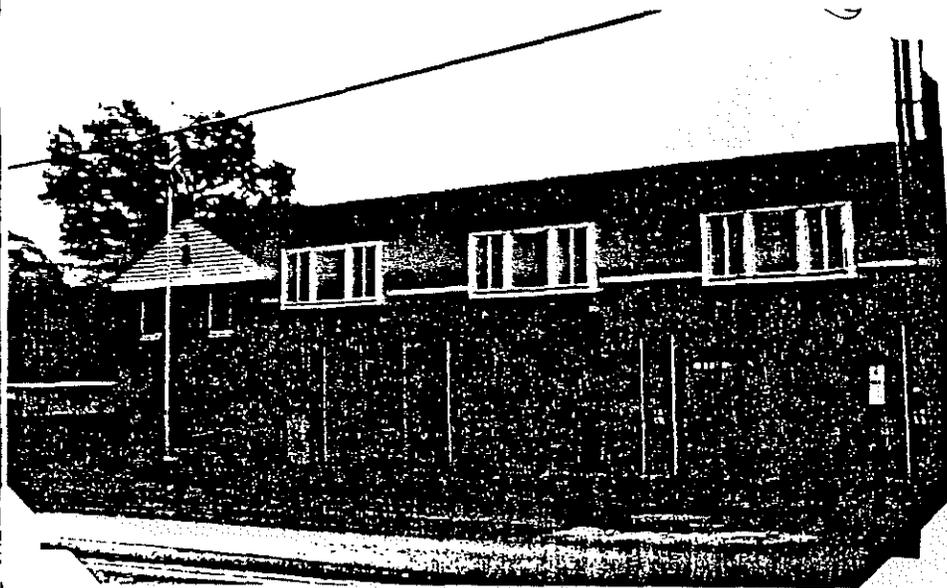
80-86 - Main Street Chester Volunteer Fire Co. #1 c. 197

CONDITION: Excellent

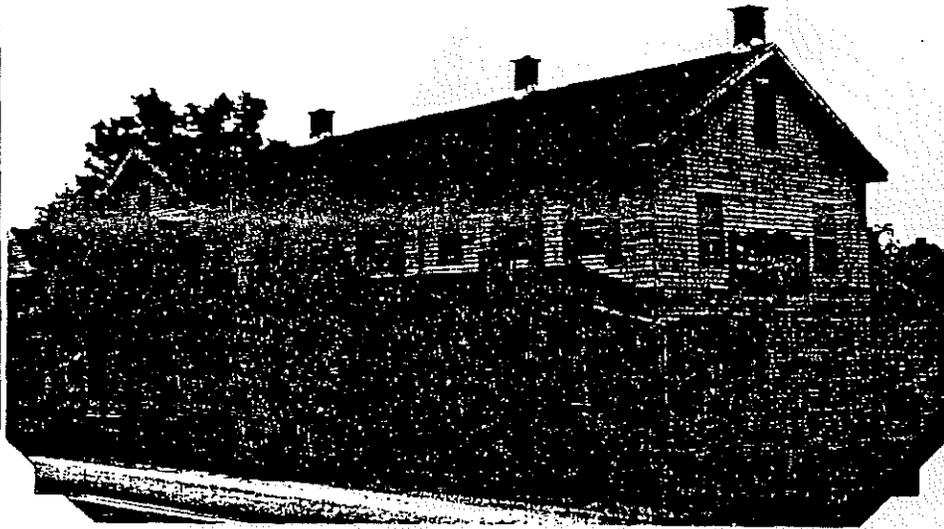
76 Main Street Old Factory Building 1844

CONDITION: Good INTEGRITY: USE: Commercial

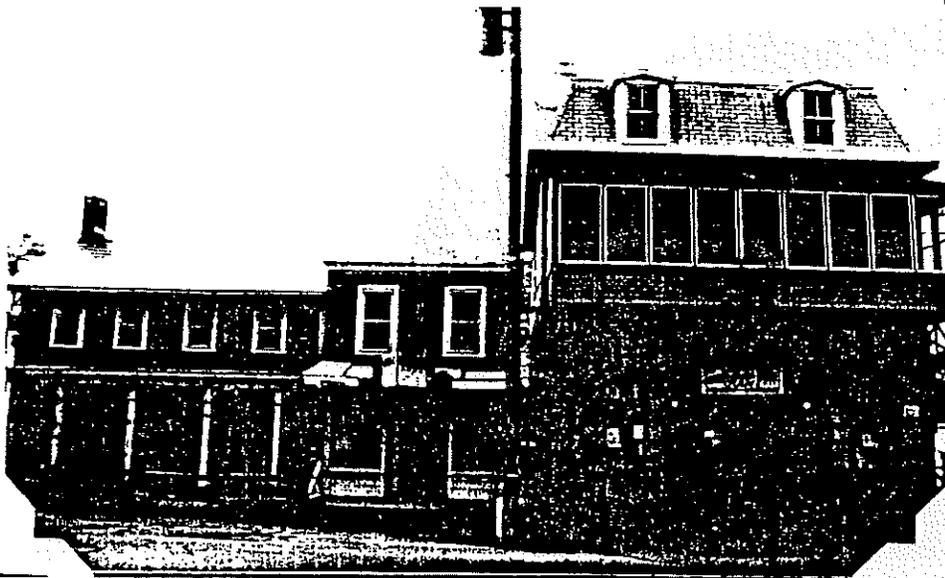
ADDRESS/DESCRIPTION: 38 Main Street

CONDITION: Good

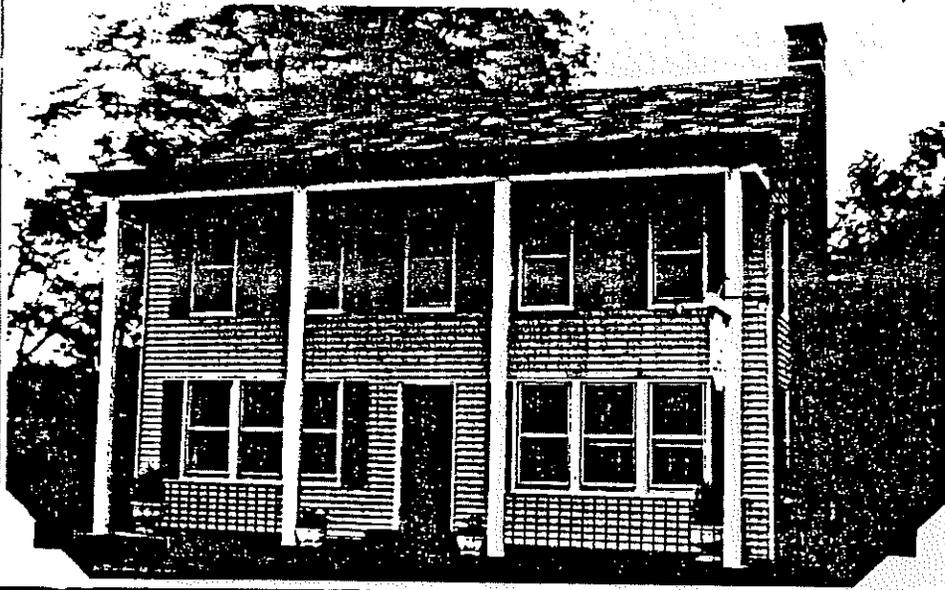
10 Main Street

Similar to #71 Main Street and half a dozen other single-pile houses, this example is somewhat atypical because of its pronounced gable-end returns. It has been degraded with synthetic siding, a 2-story porch with iron railing, first-floor picture windows with snap-in mullions, fake blinds and the removal of trim elements. Parking space is found at the front.

CONDITION: Good

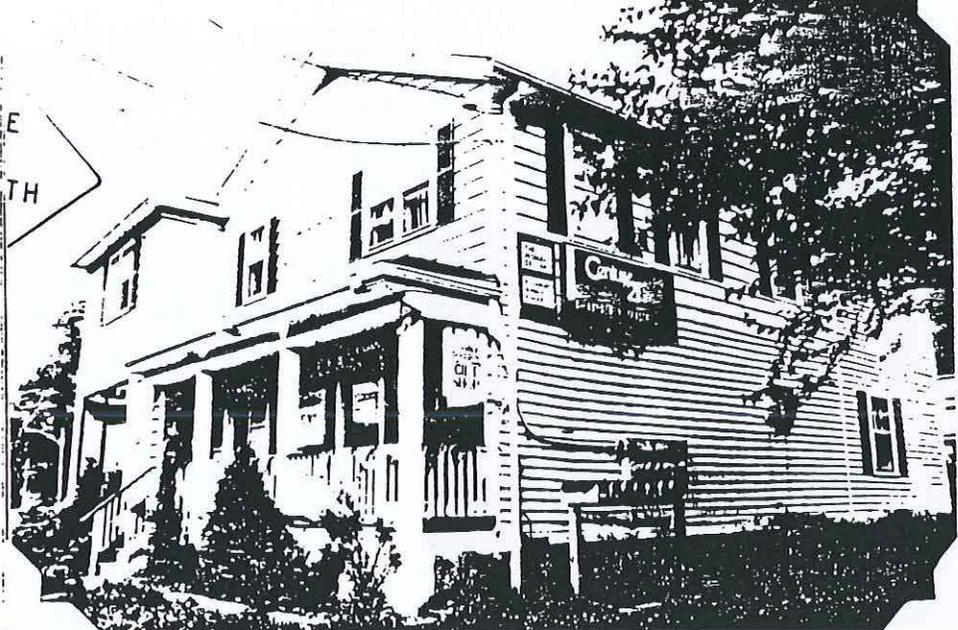
2 1/2-story "L" shape frame building with gable-end facade. Corner of "L" now filled in with 2-story flat-roof addition. Gable roof, asphalt shingles. Clapboard siding. Cement foundation. One-bay window on facade. 6/1 sash windows, fake blinds. First floor fenestration altered. Facade porch with pier supports, square railing. A vernacular "Victorian," simply detailed.

CONDITION: Fair

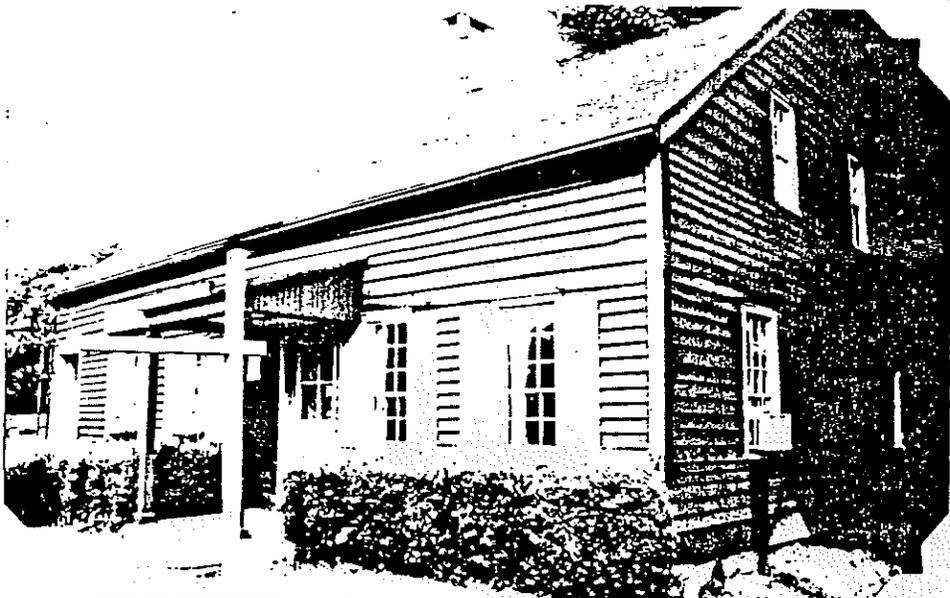
ADDRESS/DESCRIPTION: 35 Main Street

East Jersey Cottage with central door, 5-bay facade. 1 1/2 stories. Gable roof, central chimney. Clapboard siding, rubblestone foundation. 9/6 sash windows, fake blinds. Replacement casements in gable, replacement front door.

CONDITION: Fair/Good

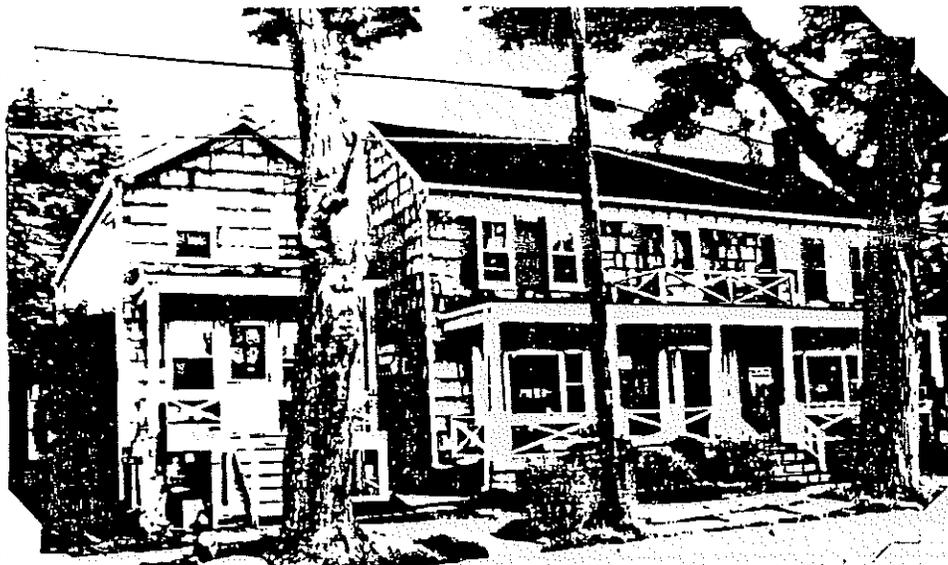
ADDRESS/DESCRIPTION: 43 Main Street

CONDITION: Good
