# MORRIS COUNTY HISTORIC SITES SURVEY

New Jersey Historic Sites Inventory  
MORRIS COUNTY CULTURAL RESOURCES SURVEY

It is this cooperative effort that made possible this Historical/Architectural Survey of the Borough of Chester, Morris County, New Jersey.

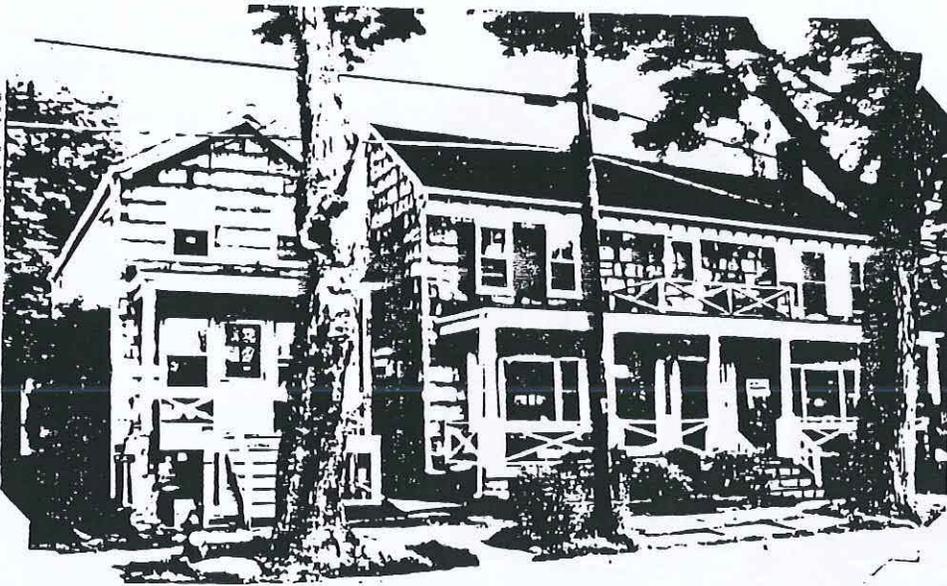
47 Main Street

CONDITION: Good

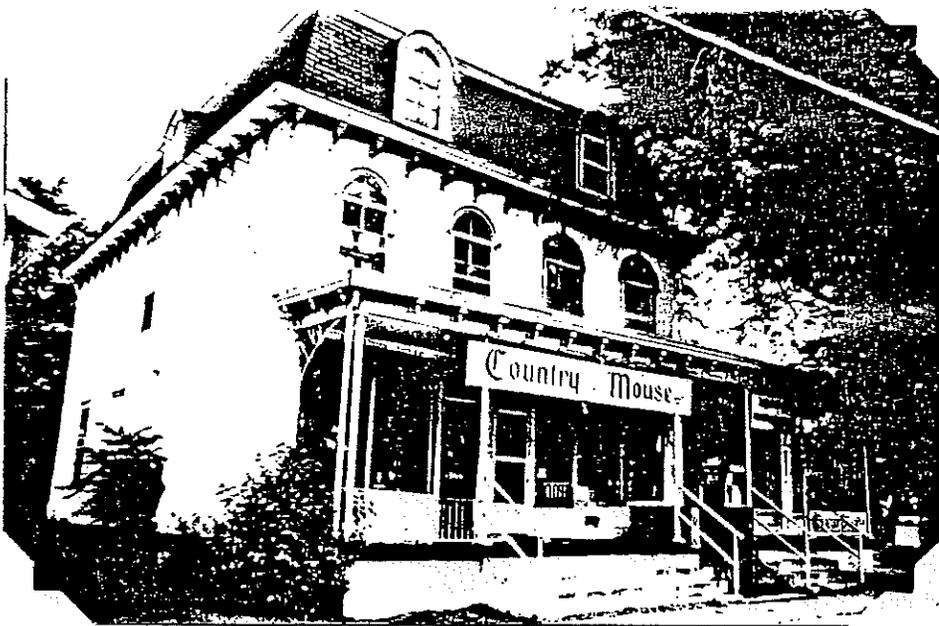
ADDRESS/DESCRIPTION: 87 Main Street "HEDGES BUILDING" 1878

Second Empire Style commercial building. 3-story, straight-sided Mansard roof, with round-arched dormers and round-headed 2/2 windows. Stucco walls, 4-bay, with round-headed 2/2 windows, arched drip molding above. Pendant drop cornice brackets at eaves and along top of facade porch. Two original cast-iron column porch supports survive; also wrought iron ornamental scrollwork at sides of porch; iron railing added later.
